Water Compliance Inspection Report

Water Compliance Inspection Potomac Electric Power Company Benning Road Generating Station NPDES No. DC0000094 Inspection Summary

NPDES Compliance Evaluation Inspection NPDES No. DC0000094 Potomac Electric Power Co (PEPCO) - Benning Generating Station, 3400 Benning Road, NE, Washington, DC 20019

Inspection Date: June 3, 2009

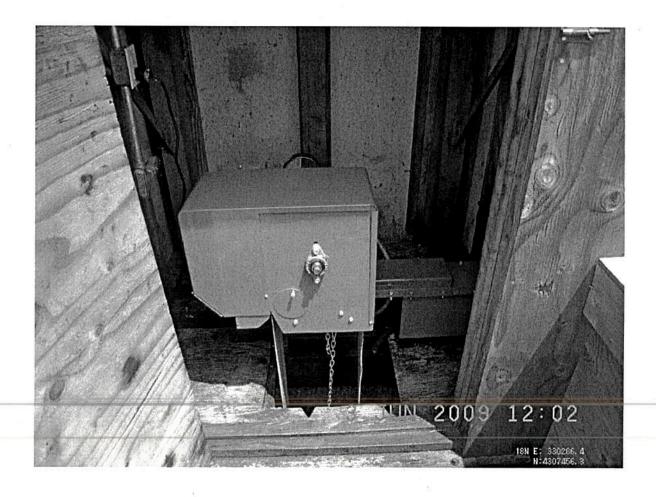
Photo 1: New skimmer for the oil/water separator at Outfall 201.

A new oil skimmer is installed at Outfall 201. An additional treatment/storage tank was installed at Outfall 003 (oil/water separator).

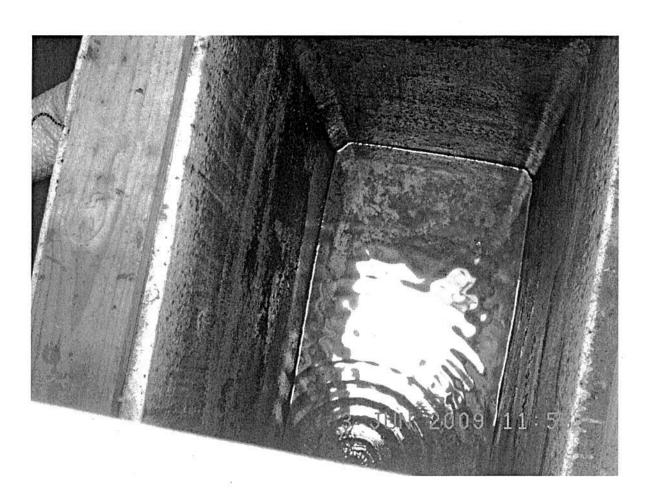
Photo 2: Oil after being separated from water at the oil/water separator at Outfall 201.

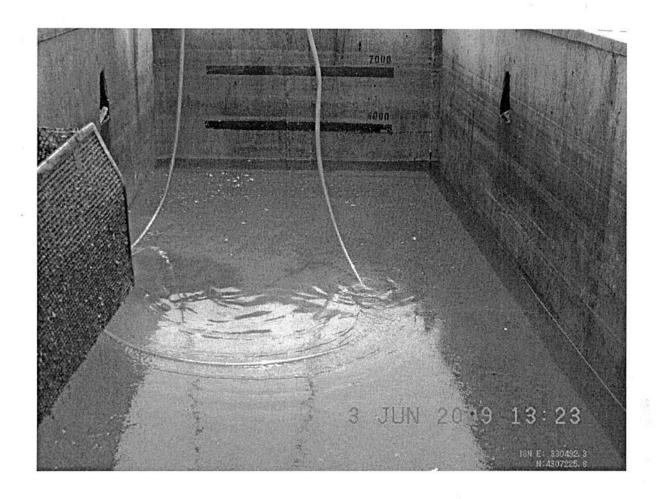
Photo 3: Tank A at the oil/water separator at Outfall 003.

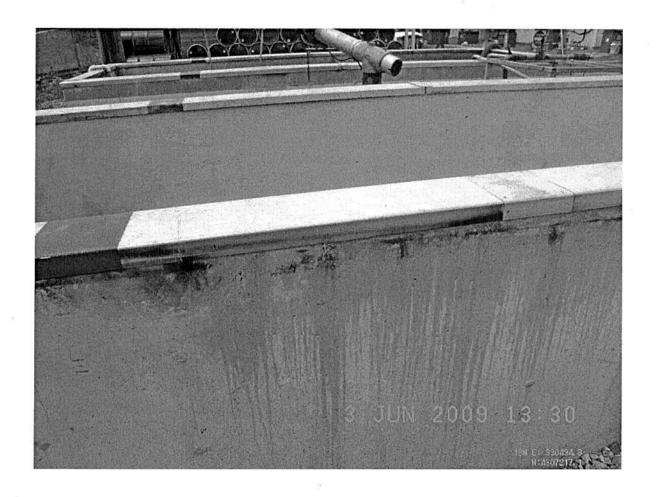
Photo 4: Skimmer and settling tanks at the oil/water separator at Outfall 003.

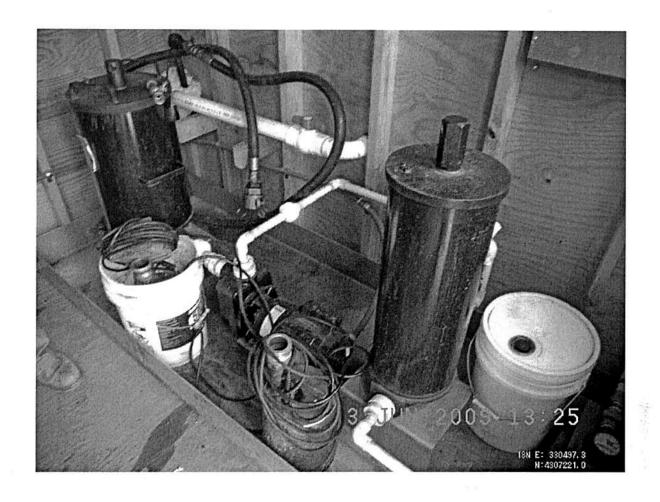
Photo 5: Carbon and cloth filters at the oil/water separator at Outfall 003.

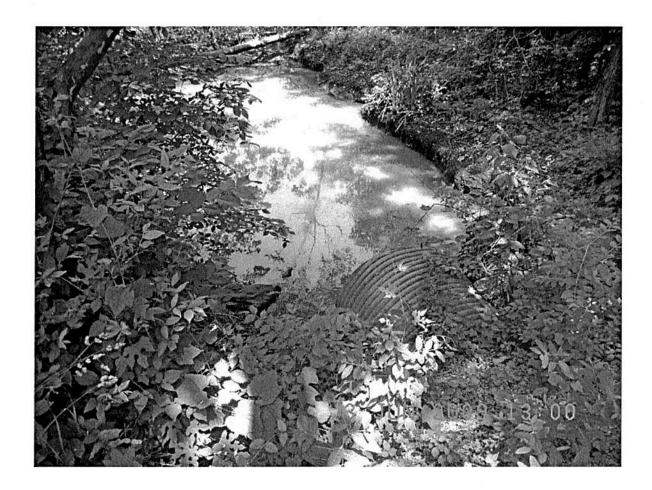
Outfall 013: Outfall 013 is the facility's largest outfall, a 54" pipe that discharges a combined waste stream of process wastewater and stormwater. More specifically, Outfall 013 discharges wastewater from 2 oil/water separators, non-contact cooling water, cooling tower blowdown, basin cleaning wastes from two cooling towers, and stormwater from several locations within the facility. The flow from Outfall 013 is estimated from the summation of the process outfalls and stormwater runoff calculated using rainfall data and runoff coefficients for the various sections of the facility. This approach appears to be consistent with Part A of the permit. The outfall discharges into wetlands, a few hundred feet from the Anacostia River. On the date of the inspection, there was no non-contact cooling water exiting the outfall. However, the only flow in Outfall 013 was from the oil/water separator(s) and possibly groundwater seepage. Although slight turbulence indicated flow at the partially submerged outfall pipe, no plume could otherwise be distinguished as the outfall pipe discharged into a pool of muddy water.

Photo 6: Main Outfall 013 at the Anacostia River wetlands. The outfall is partially submerged in a pool of muddy water, hence no plume could be distinguished due to the muddy pool water. Only slight turbulence at the pool's surface, otherwise, indicated a discharge flow at this time.

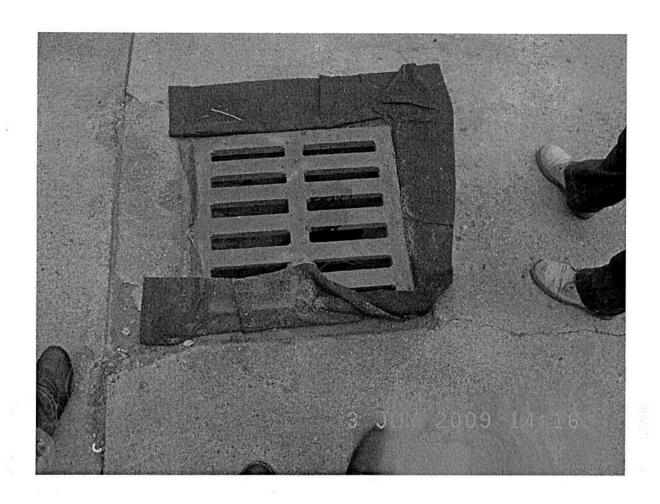
Outfalls 402 and 416: These are internal stormwater inlets receiving no flow at the time of inspection. The outfalls had oil booms and filter cloth inside and appeared to be in good

Photo 7: Oil boom/filter cloth inside an inlet at Outfall 416. (Typical @ several inlets.)

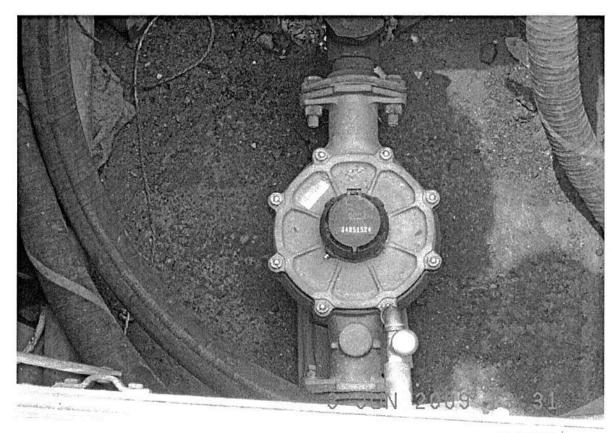
Photo 8: Flow meter at the oil/water separator at Outfall 003.

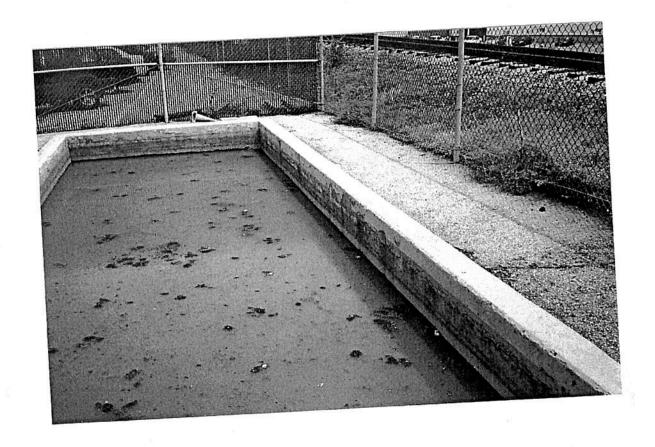
Outfall 010: Outfall 010 is an internal outfall for the drying pit where spray cleaning water from manholes is collected. PEPCO reportedly has (b)locked its discharge (stopped discharging) for the past few years and indicated that it will be removed from the permit (photo 9).

Photo 9. Drying pit where spray cleaning water from manholes is collected. PEPCO reportedly has (b)locked its discharge (stopped discharging) for the past few years.

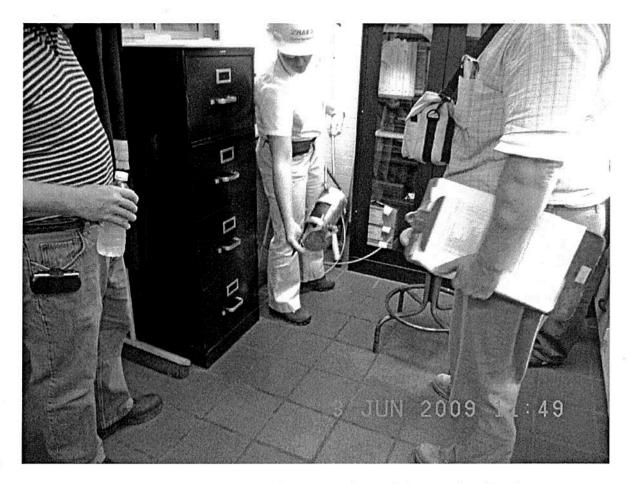
During the 2008 inspection, it was observed that the facility was not using approved protocols to collect samples for oil and grease. The facility representative had indicated that a bucket was used to collect the sample and then the sample is poured into glass bottles for shipment to the laboratory for analysis. During the 2009 inspection samples for oil and grease are now collected directly in glass containers using plastic and stainless steel sample poles with container holders (photo 10).

Photo 10. Plastic and stainless steel equipment used to hold bottles for oil and grease samples. The equipment was designed as a corrective action based on 2008 inspection findings.

- (i) Samples for oil and grease are now collected directly in glass containers with implementation of plastic and stainless steel sample poles with container holders (photo 9).
- (ii) pH and chlorine residual samples are collected and analyzed within 15 minutes as now documented in lab's log books.
- (iii) Sample temperatures are now documented on chain of custody forms.
- (iv) NAES's monthly stormwater inspection records are now essentially the same as PEPCO's
